DEPARTMENT OF TRANSPORTATION

Contract #: 04-0120F4Cty: SF/ALA Rte: 80 PM: 13.2/13.9File #: 69.28**WELDING INSPECTION REPORT****Resident Engineer:**Pursell, Gary**Address:** 333 Burma Road**City:** Oakland, CA 94607**Report No:** WIR-002930**Date Inspected:** 30-May-2008**Project Name:** SAS Superstructure**OSM Arrival Time:** 1330**Prime Contractor:** American Bridge/Fluor Enterprises, a JV**OSM Departure Time:** 2230**Contractor:** Zhenhua Port Machinery Company, Ltd (ZPMC), Changxing Island **Location:** Shanghai, China

Orthotropic Box Girder (OBG) Fabrication:

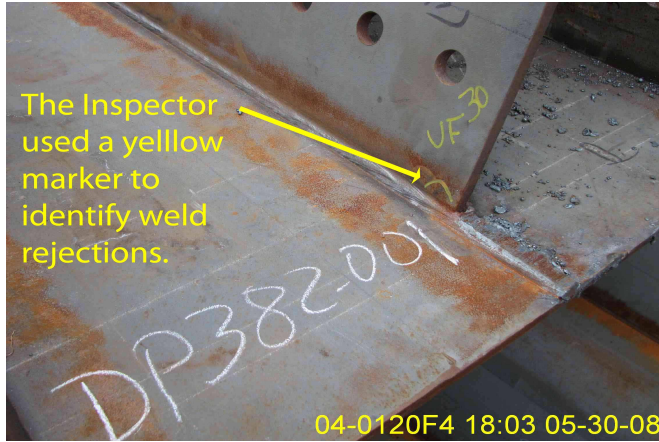
The QA Inspector performed random visual inspections of deck plate DP382-001 closed rib welds # 1, 2, 3, 4, 5, 6, 7, 8, 9 and 10. The QA Inspector used a yellow marker to identify locations on these welds that have various degrees of weld insufficient fill, weld overlap, and other similar weld conditions. The results of these inspections were documented on forms titled: "Caltrans QA Visual Weld Inspection Report for the OBG Deck Panels". These completed forms have been submitted to engineering for review.
